Figure 2: Site Analysis Plan

## 2 The Site and its Locality

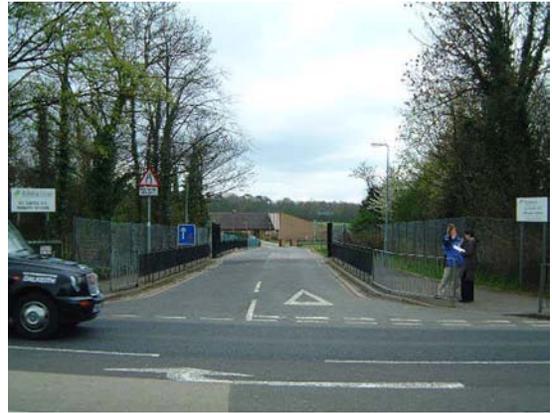
The existing entrance to the site and the school from A68

- 2.5 St. David's RC Primary School is located adjacent to the development site, however the physical boundary to the school is not clearly defined. The size of the area of land currently associated with the school is to be reduced. Neither the school nor the janitor's house form part of the available development area. There is one vehicle access route into the site which serves the school at present.

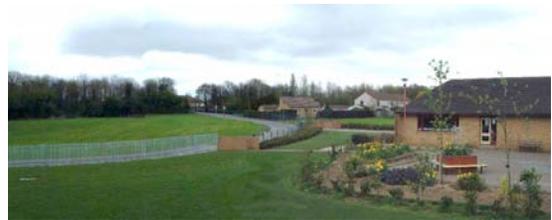
The site: looking towards the A68 and the school

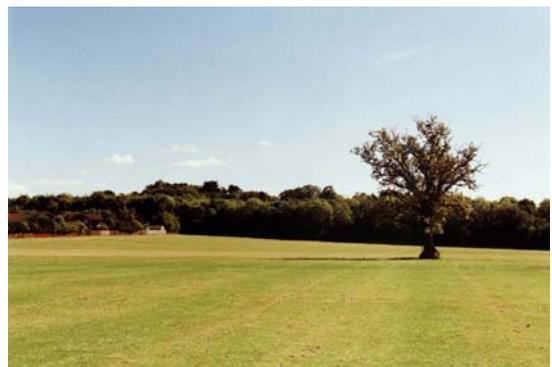
The site: looking towards the Ash tree

- 2.4 One large single and over mature Ash tree is located centrally in the playing field. It is possibly a remnant of an old field boundary or parkland tree. It appears to be in a poor state of health but adds character to the site. The developer will be required to carry out a Tree Surgeon's Report to establish whether the tree is worth retaining. The report should be submitted and approved prior to any work to the tree being carried out.

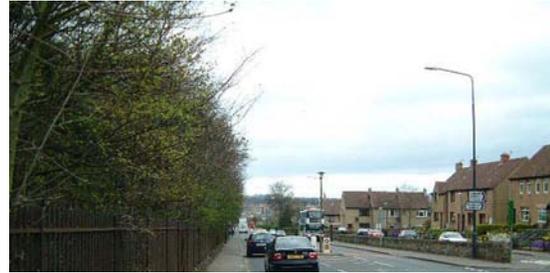
The A68 and the site frontage tree belt

- **Topography:** The topographical survey reveals that the site is generally level. The woodland tree belt next to Lauder Road is also relatively flat, apart from a steep but narrow hollow that contains an exposed wastewater pipe. The vehicle turning circle is also level but the access road inclines gently upwards to the A68 junction.

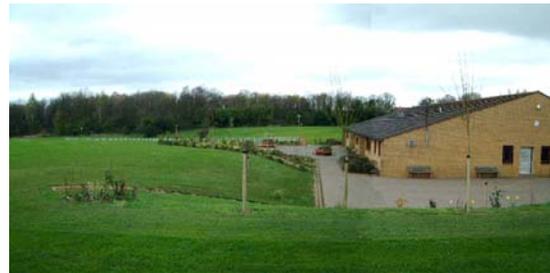
The site and the school

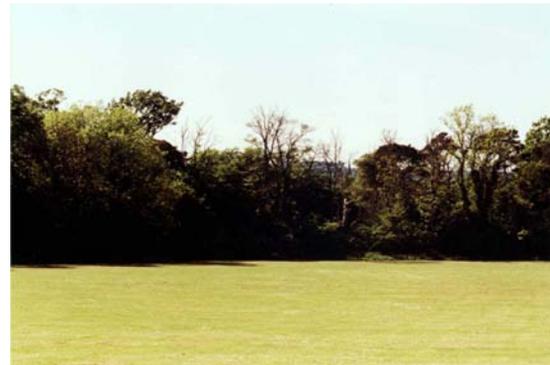
The woodland around the site boundaries

- **Ground Conditions:** The site appears generally dry and well drained with no visible signs of significant drainage problems.
  - **Climate:** The existing trees around the site's boundaries give it a natural protection from south-westerly prevailing winds in the spring and summer months.
